# Manhole Inspection Summary

Manhole # S47Y1\_007MH

Insp Date: **6/2/09 8:47 AM**

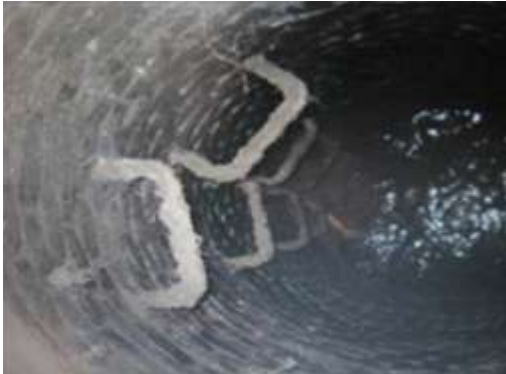
Count: **10** Missing: **0** ☒ Corroded

steps

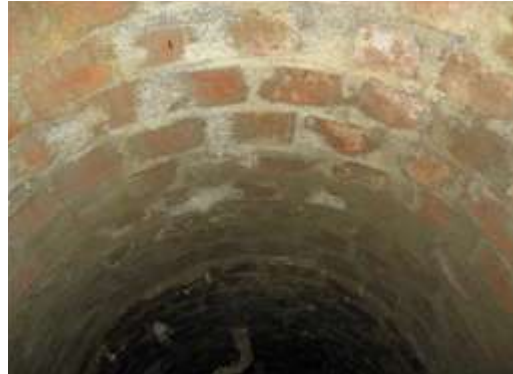
Defect 1

Condition: ☐ Sound ☒ Cracked ☐ Root Intrusion ☐ Loose Brick ☒ Deteriorated

Infiltration: ☐ None ☐ Joint ☐ Cracks ☐ Mortar ☐ Roots ☒ Wall

wall infiltration

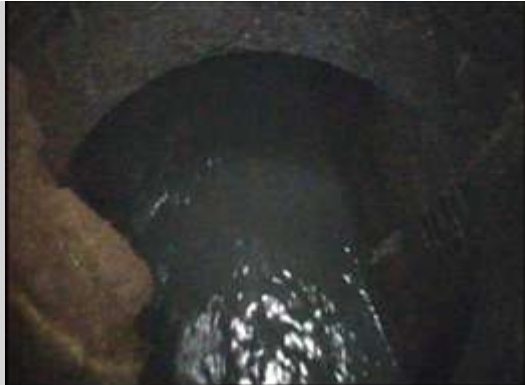
12 O'Clock Outflow

Pipe Height: **43.2** (in.) Rod and Bar (Angled)  
Pipe Material: **Concrete** ☐ Pipe Lined  
Invert Depth: **19.72** (ft.) Flow Characteristics: **Fast**  
Deposits: ☒ None ☐ Mud ☐ Sludge ☐ Debris ☐ Grease  
Silt Depth: (in.) Deposits Extent:  
Infiltration: **None** Pipe Seal Cond: **Sound**

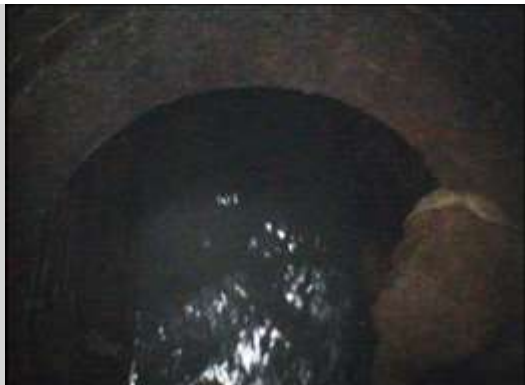
6 O'Clock Inflow

Pipe Height: **43.2** (in.) Rod and Bar (Angled)  
Pipe Material: **Concrete** ☐ Pipe Lined  
Invert Depth: **19.60** (ft.) Flow Characteristics: **Fast**  
Deposits: ☒ None ☐ Mud ☐ Sludge ☐ Debris ☐ Grease  
Silt Depth: (in.) Deposits Extent:  
Infiltration: **None** Pipe Seal Cond: **Sound**

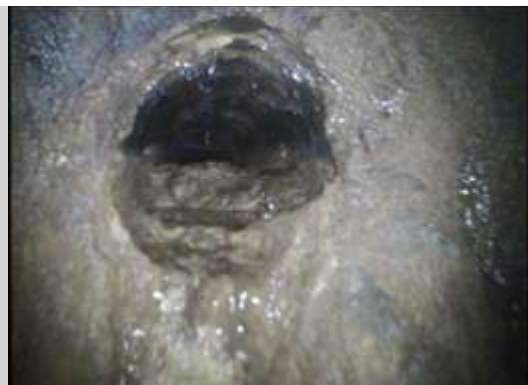
9 O'Clock Inflow

Deposits: ☐ None ☐ Mud ☒ **Sludge** ☒ **Debris** ☒ **Grease**

Silt Depth: **4** (in.) Deposits Extent: **Heavy**
